Dynamic Insulation

Gaia Architects & Gaia Research

What is Dynamic Insulation?

This report is produced as a result of research directed by Gaia Research, which comprised a monitoring study of the dynamic insulation at MCLC.

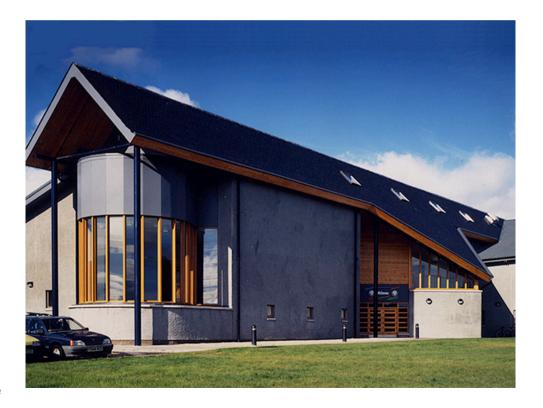
On a sunny day, solar heat gains into the roof space provided valuable air preheating. However, in summer this may cause overheating. It was thought to be worth considering switching off the supply fans when the roof space temperature was over, say, 24°C. The windows could be used for ventilation but care would be required to prevent unwanted and uncontrolled air movement.

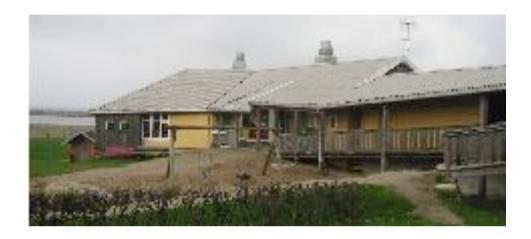
The use of the heater battery caused confusion. It had been understood that this was intended for use when the heating capacity was insufficient to create a temperature of 30°C and to provide preheat capacity up to 10-15°C in the event of problems with the dynamic insulation. There was concern that it was being used excessively.
